Building resilience: How "Retele Electrice" as DSO is facing with energy transition

RSEEC 2025 NATIONAL COMMITTEES of CIGRE (4th edition), 23 January 2025, Rome, Italy

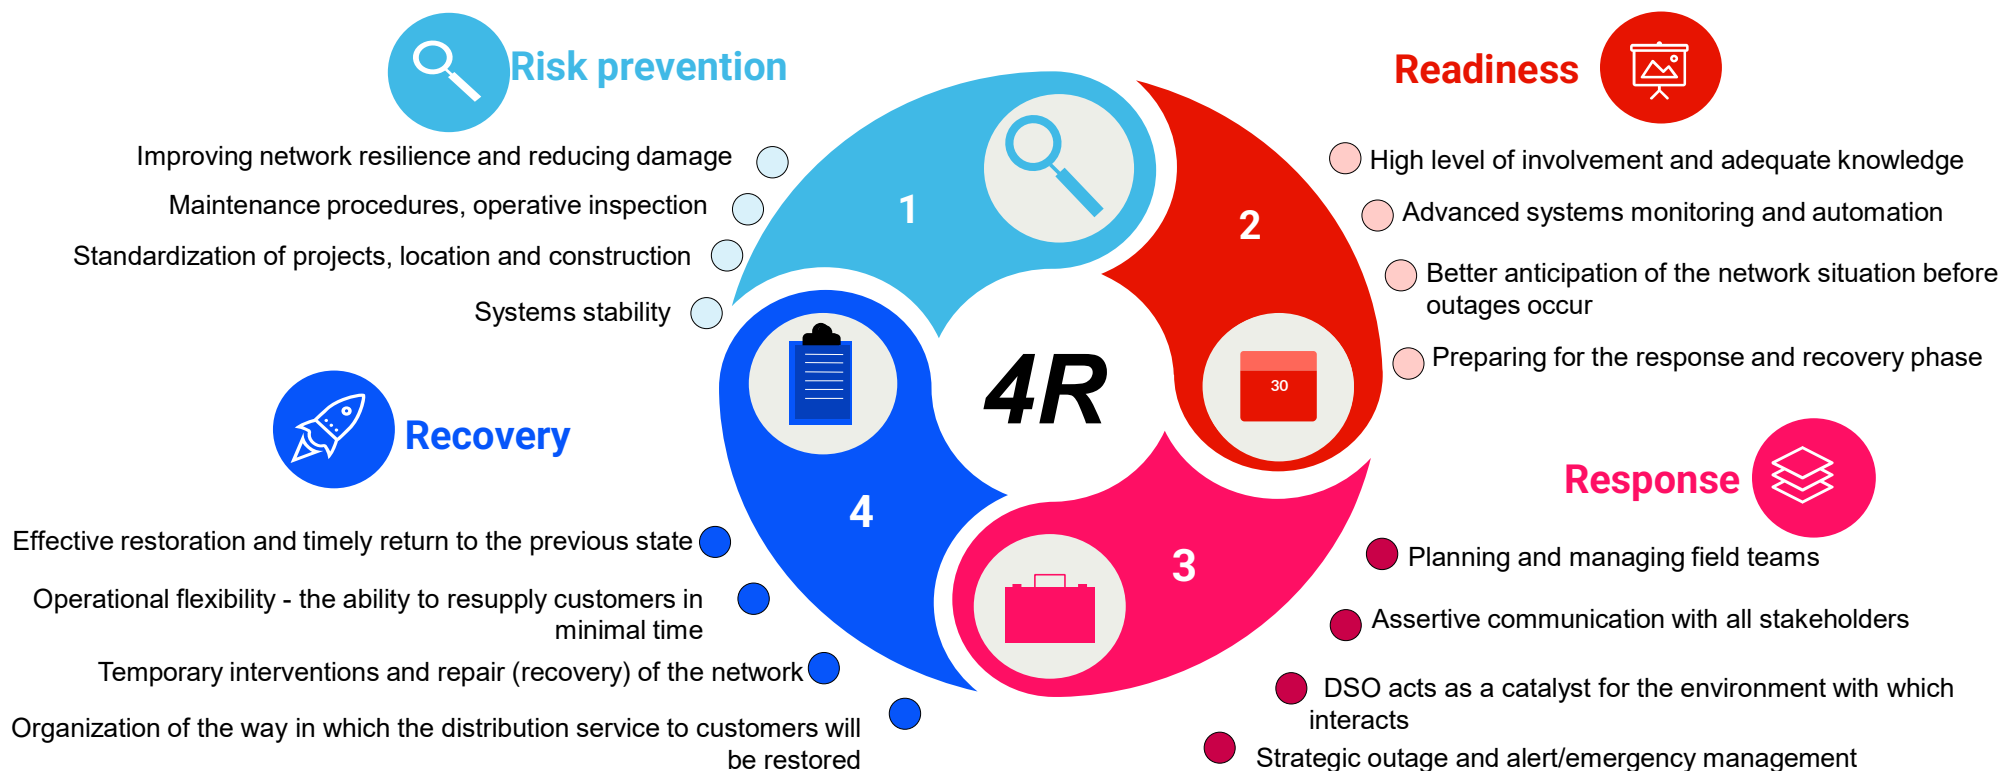
Innovative resilience/operational strategy (in 4 stages)

1 PRE-ALERT (Readiness / Response)

- Efficacy
- Forecasting tools
- Mobilization of teams and resources in the field
- Execution of checklists

2 MANEUVERS IN REMOTE CONTROL (Readiness / Response)

- Preparation of the crisis chamber
- Prioritization of maneuvers
- Resource mobilization and defect selection

3 REALIMENTARE (Răspuns / Recuperare)

- Knowledge of faults localization
- Sending teams to the field
- Assignment and monitoring of tasks
- Immediate activation of generator sets
- Mobile emergency transformer stations
- Task Force Management
- Managing Network Damage Documentation (Photos/Videos)

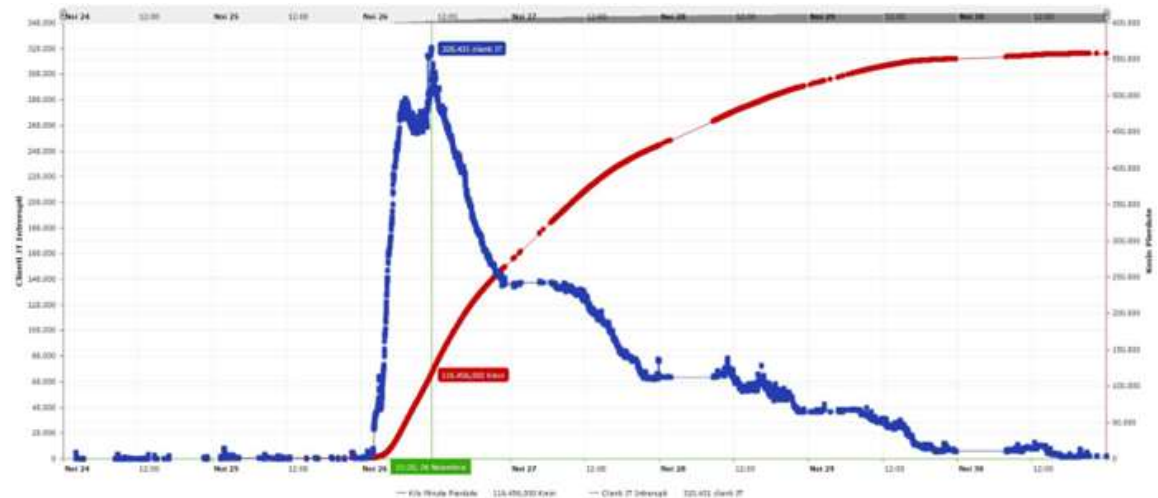
Due to the extreme weather phenomena, which had a very long duration of manifestation, the electrical networks in the area served by the DSO were affected. Thus, the triggering of high and medium voltage power lines, as well as disturbances in the low voltage network followed the trend of weather phenomena, with a **maximum on 26.11.2023 at 11:20 a.m.**, when a number of **320.431 low voltage customers were without power from the medium and high voltage networks**

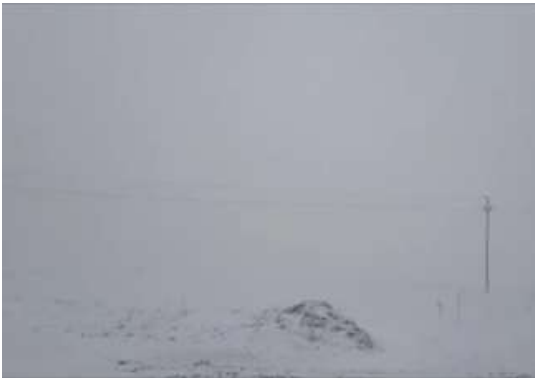
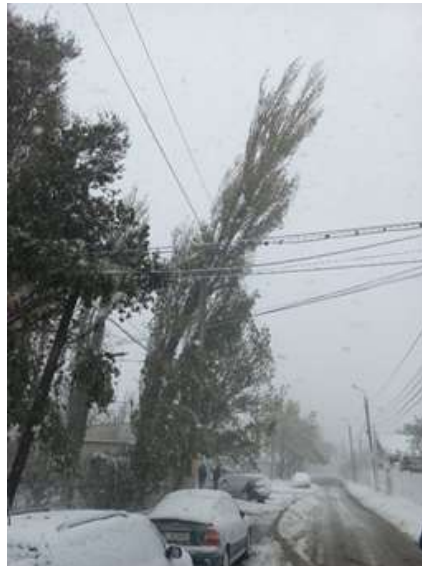
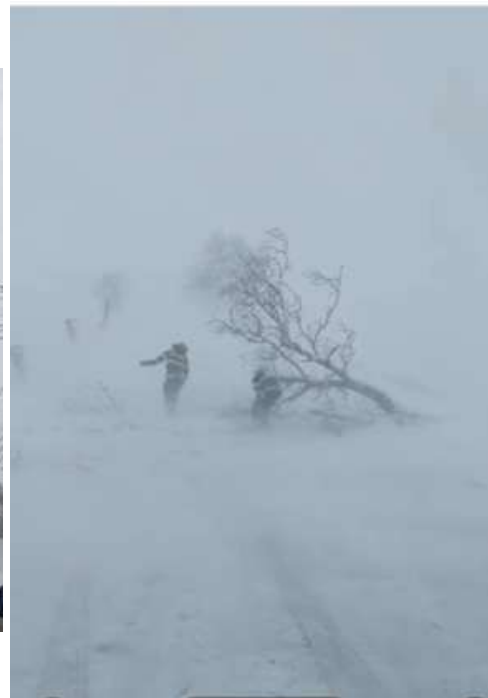
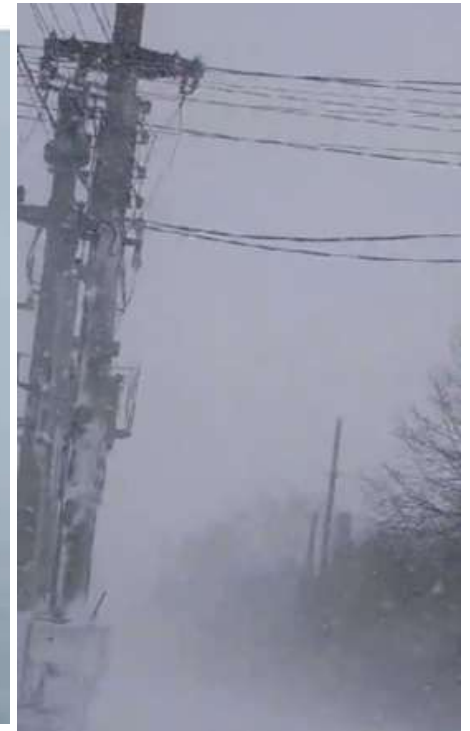
Given the unfavorable weather conditions, as well as the difficult access in many areas, due to the closed roads, the interventions are very difficult, and the electricity supply situation during the period in which the extended red code and orange codes were affected, was a dynamic one.

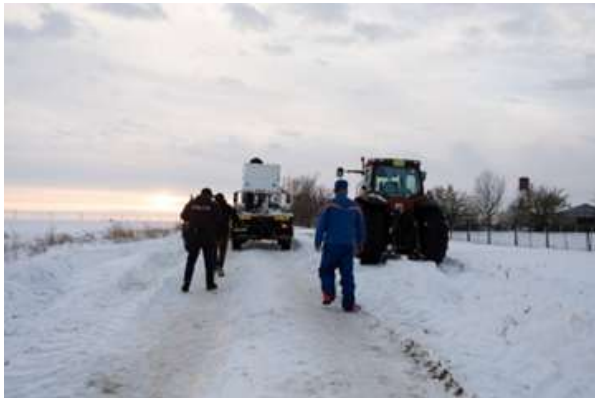
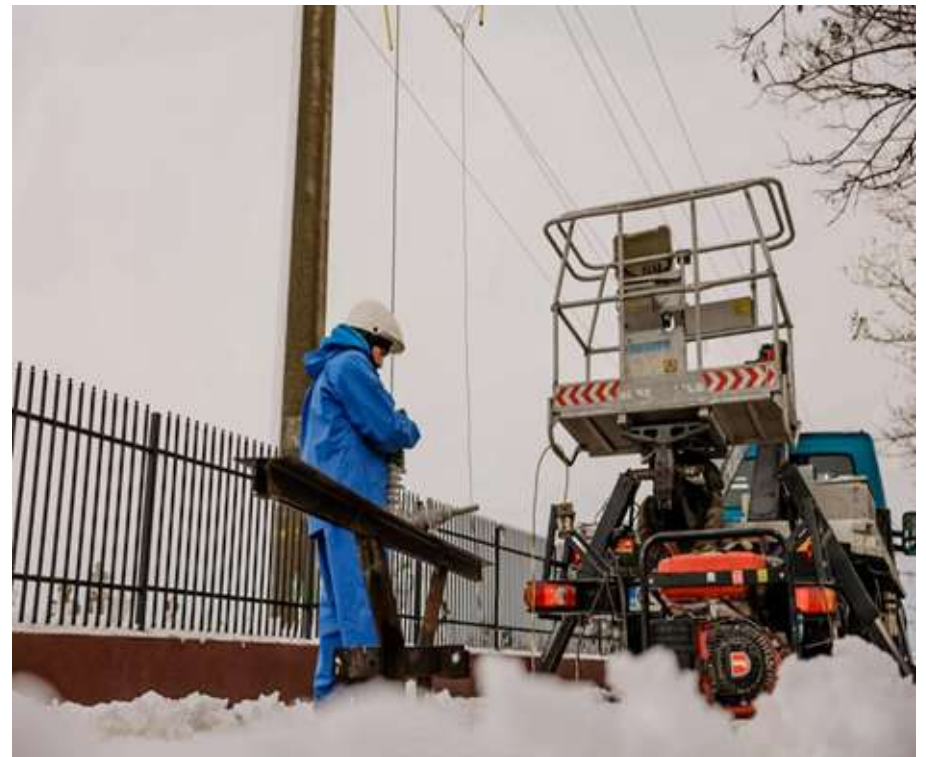
The strategy adopted by the company was to intervene and fix the faults in the descending order of the voltage level and the number of affected customers, focusing on the networks that supplied domestic customers, so that the actions taken to restore the electricity supply have as big an impact as possible.

After most of the medium voltage lines supplying household customers were repaired, thus significantly reducing the total number of affected customers, the next step was to intervene in the low voltage network, primarily for the collective disturbances that affected a large number of customers. In order to increase the efficiency of the interventions, taking into account the long distances that had to be covered to remedy the defects in the network, as well as the state of the roads, once the works were initiated in a locality, action was taken until all disturbances were completed.

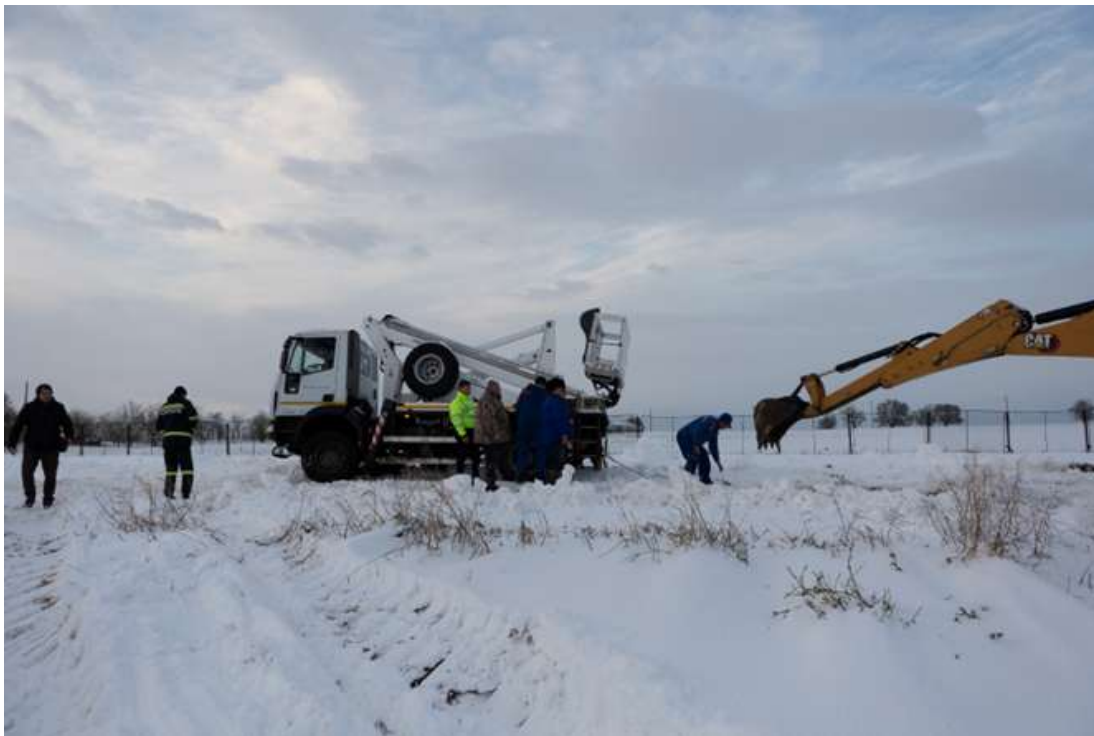
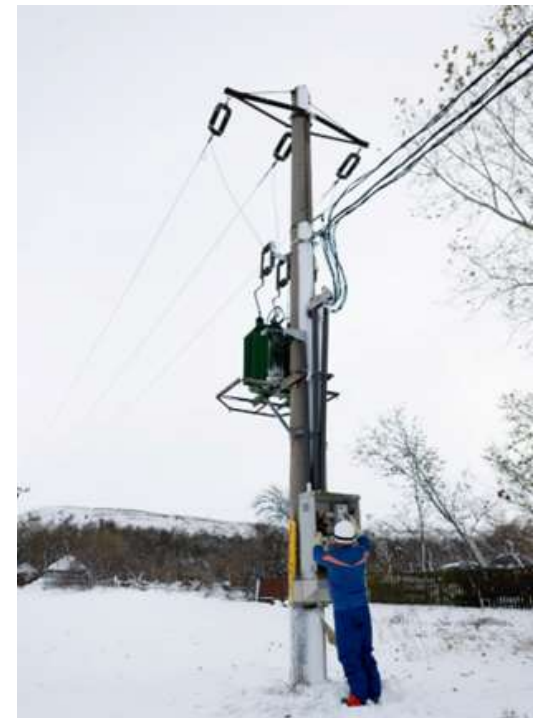
Particular attention was paid to ensuring the utilities of the cities of vital importance for the inhabitants (drinking water supply, district heating, natural gas) through targeted repairs in the medium and low voltage networks as well as through the installation of own and third-party generating groups. The company has also ensured the fuel supply of these generators, so that the discomfort felt by customers is as little as possible.

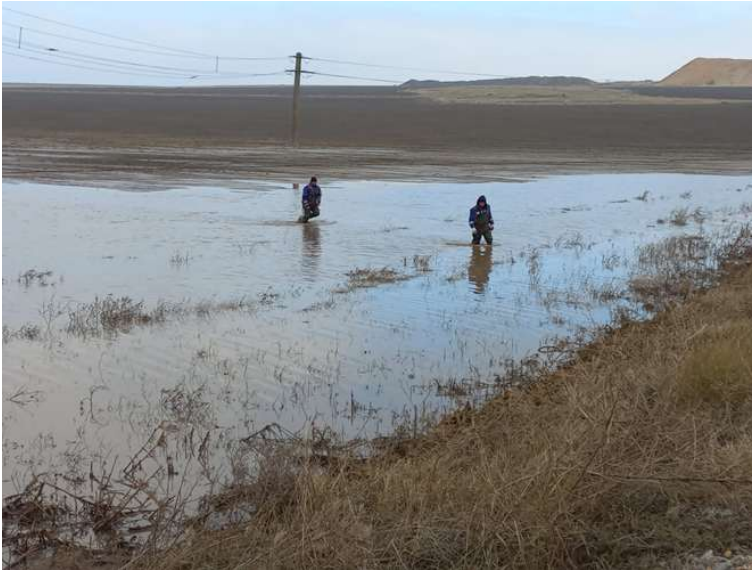
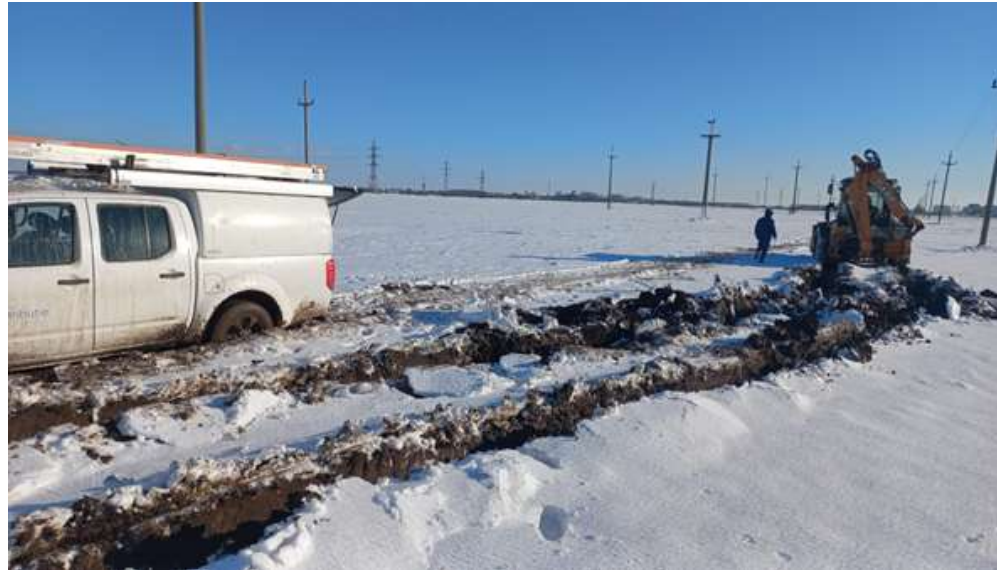
An essential factor that prevented interventions to remedy the damage was the generalized lack of communications starting with the middle of the day on 26.11.2023, both for the transmission of data, necessary for remote control in the transformer stations and for the medium voltage equipment in transformer stations and overhead power lines, as well as voice communications for the coordination of maneuvers by dispatchers and low-voltage interventions between teams and coordinators Local. The lack of telephone signal for data and voice remained generalized until the middle of the day on 28.11.2023 when, as the power supply of the pillars of mobile operators was successful, the lack of signal became local. We specify that mobile operators have as a backup source for the supply of electricity UPSs with a relatively short operating life, which led us into a vicious circle: lack of electricity supply to the pillars - lack of communications - impossibility of performing maneuvers to locate and isolate defects - impossibility of moving on public roads of the generating groups for powering the pillars.

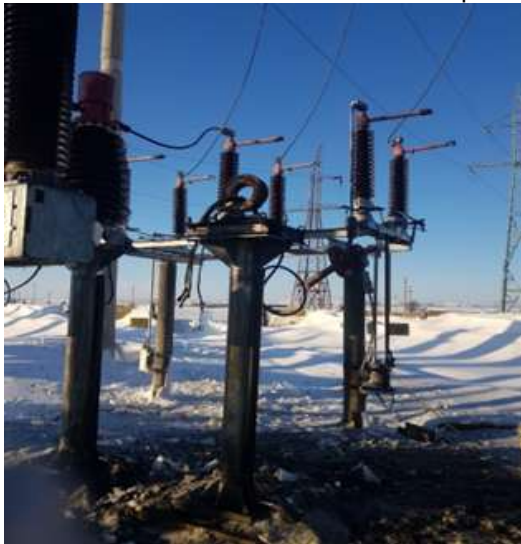
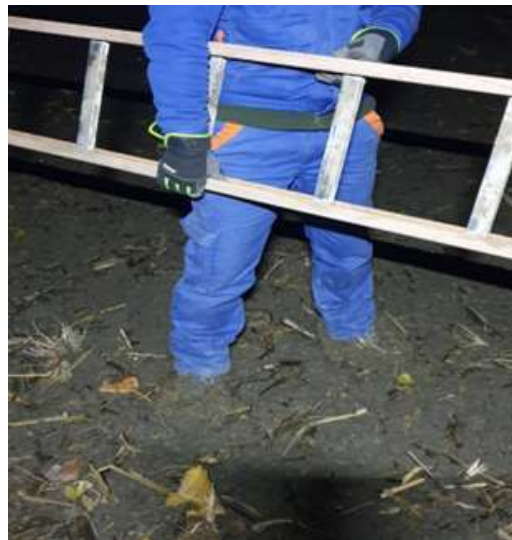
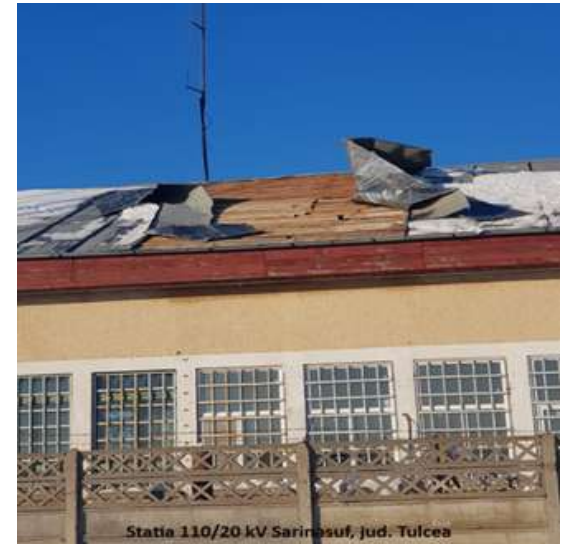
A special accident occurred in the 110/20 kV Sarinasuf substation in the Tulcea city, which supplies the entire Danube delta with electricity through the 110/20 kV Crisan station. The wind with gust speeds over 110 km/h tore off a piece of the station's roof and knocked a 110 kV current measuring transformer from its pedestal, which led to the tripping of the 110 kV Tulcea Vest-Sarinasuf line and the lack of electricity supply of all customers from the Danube delta and part of the continental part of the city.

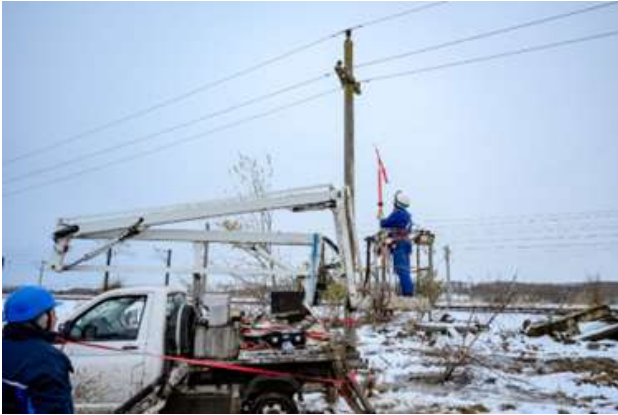
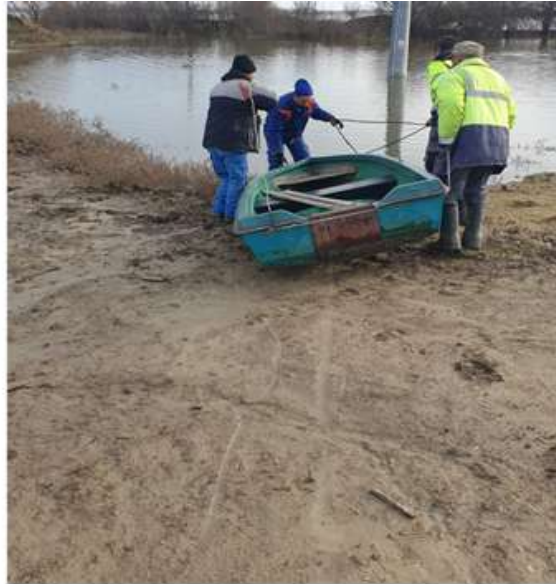
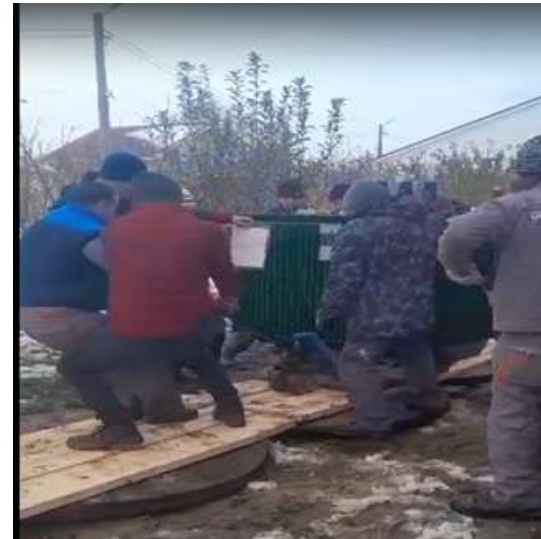
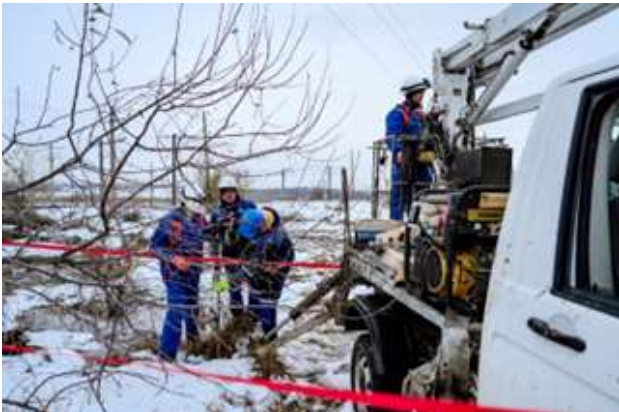
Due to the difficult access, the interventions to replace the defective transformers were equally complicated. As the machines (trailer, crane, etc.) could not reach the vicinity of the transformer substations, the transformers were transported, handled and mounted manually
